Electrical Imaging Resistivity Fence Diagram of Profiles Showing Relationships of Subsurface Features at Location of Subsiding Bridge

The northbound bridge piers began subsiding due to sinkhole activity along the stream forcing closure of the northbound roadway. SuperSting resistivity geophysics showed that most of the carbonate bedrock underlying the bridges to at least 200 feet was severely weathered except where the rock was dolomitic. Numerous test borings confirmed the findings of the geophysics.

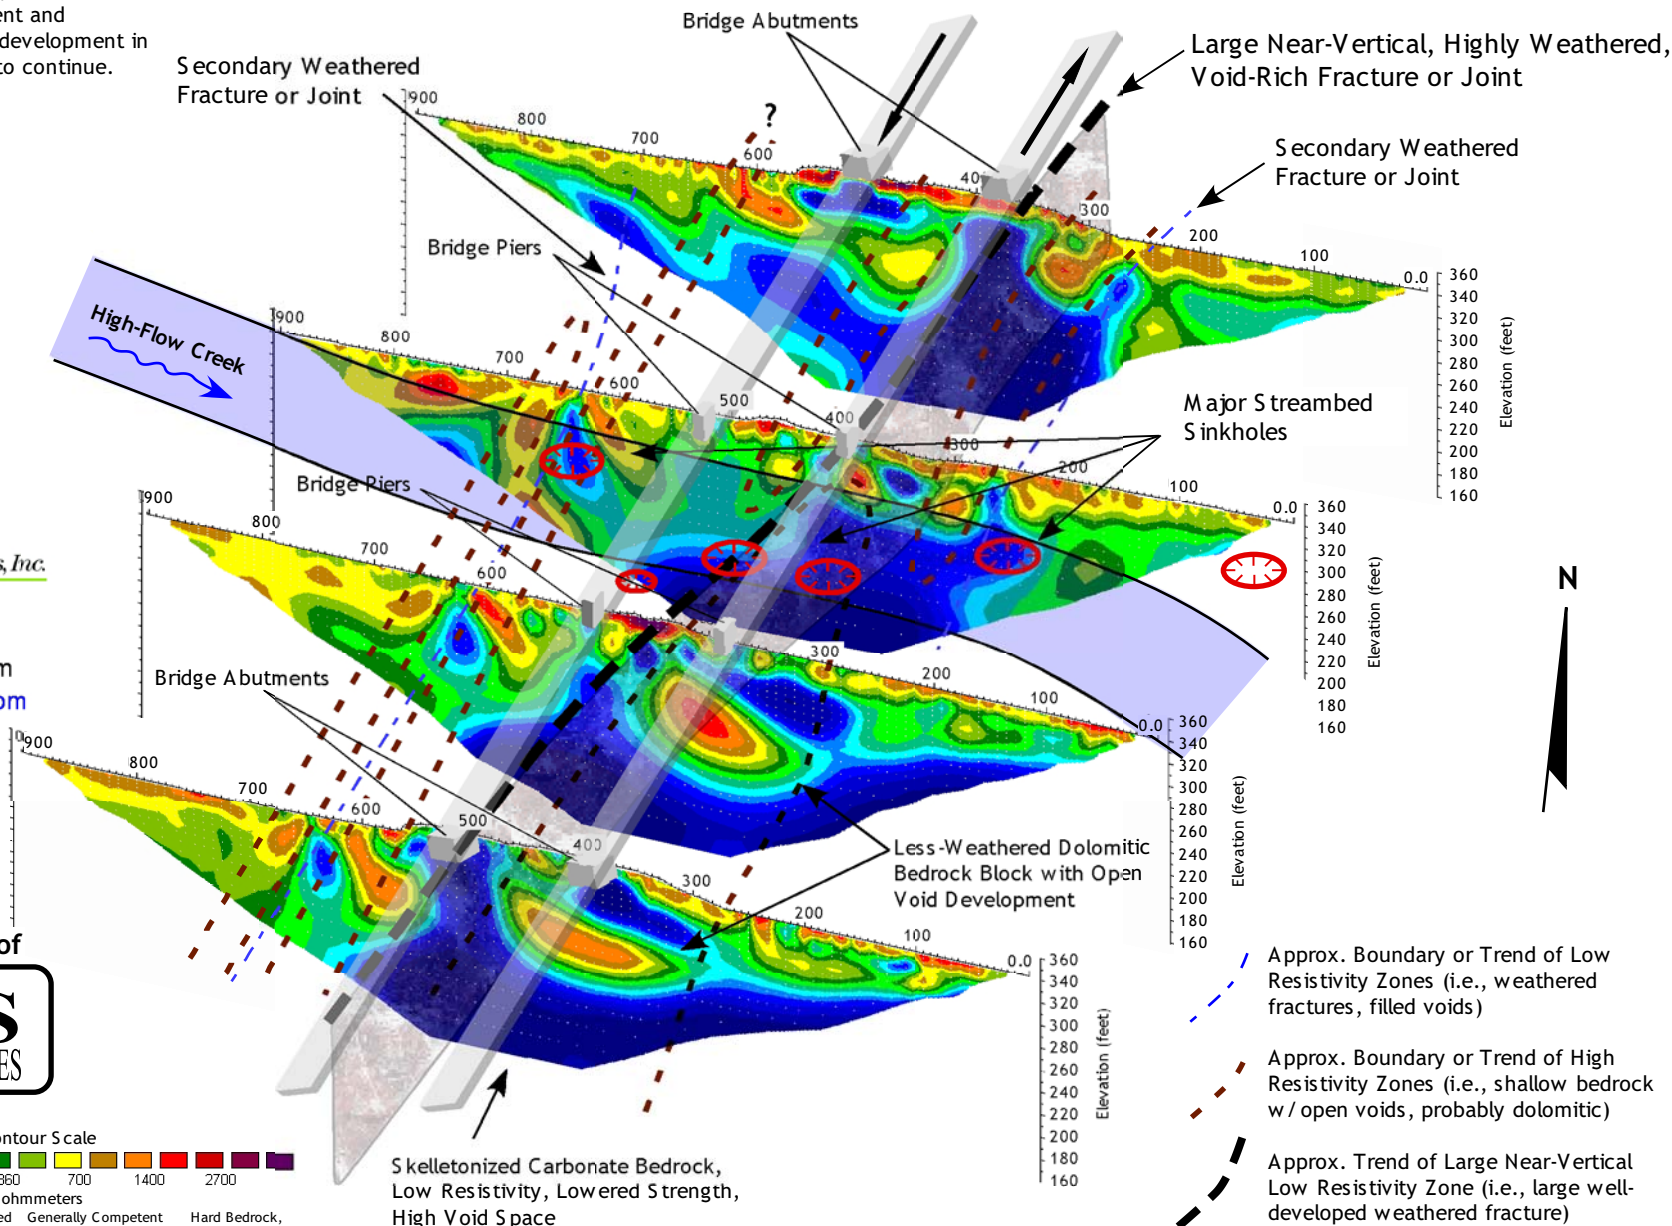
Analysis indicates that a significant joint or fracture zone crosses the creek as shown resulting in several sinkholes and water loss further driving karst development. Deeper limestone bedrock has probably suffered a high degree of void development and skeletonization. Further karst development in and around the creek is likely to continue.

Orientations are approximate. Bedrock bedding strike is roughly ENE to WSW.
