Geotechnical Ground Truthing

Sink Hole in Leaking Retention Pond

Objective: Map the extent of a sink hole and locate zones where water is leaking from a pond

Site: Retention pond and sink hole near Lenoir City, Tennessee, USA

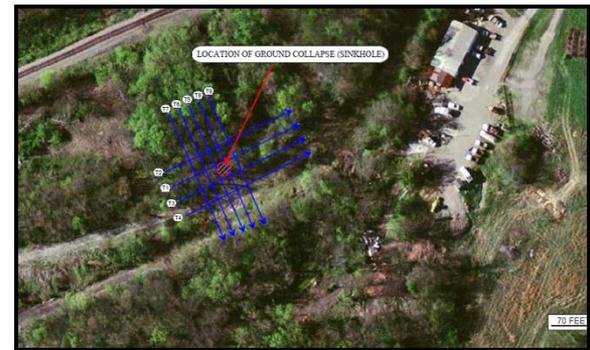
SuperStingR8 and resistivity cable

Instrument: SuperStingR8 with 112 total electrodes arranged in a 4x28 3D grid with 16x8ft spacing

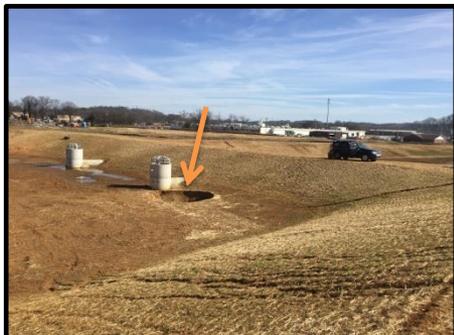
Location of known sinkhole
