Earthen Dams: locating leakage with resistivity imaging surveys

Objective: Locate leakage through karst limestone at the bottom of an earthen dam using resistivity imaging surveys

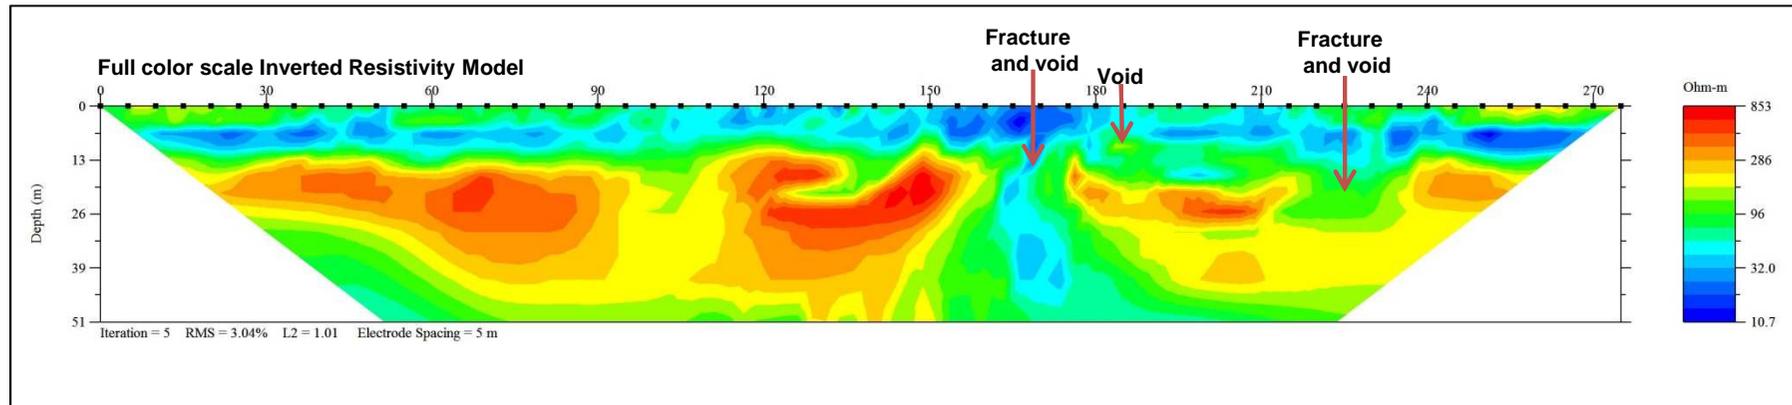
Results: Low resistivity anomalies located around coordinates 170 and 185 and 225 have now been drilled and grouted. The anomalies at 170m and 225m are fracture zones with associated voids. The anomaly at 185m is a void. These systems were injected with 703 cubic meters of grout. The water in the dam has raised significantly after resistivity imaging surveys and grouting of these 15 other similar targets.

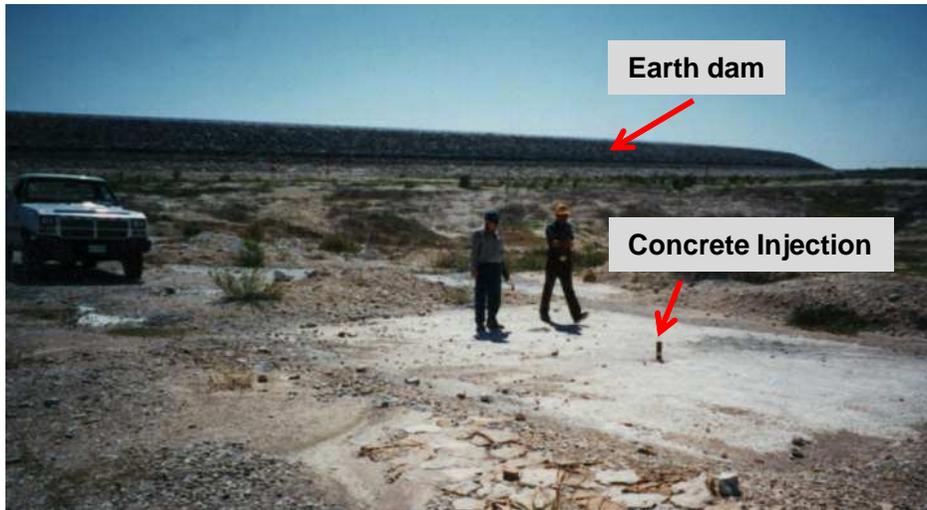
Since 1996 the reservoir has filled significantly
