# Geotechnical Site Characterization in a Landslide Study in a Dam and Detection of Possible Cavities

**Objective:** Determine through 2D Electrical Resistivity Tomography, a landslide in a Dam which affects part of the existing main road corresponding to the Pamplona – Cúcuta and the detection of possible cavities .

**Survey site:** Municipio Vélez, Departamento de Santander, Colombia.

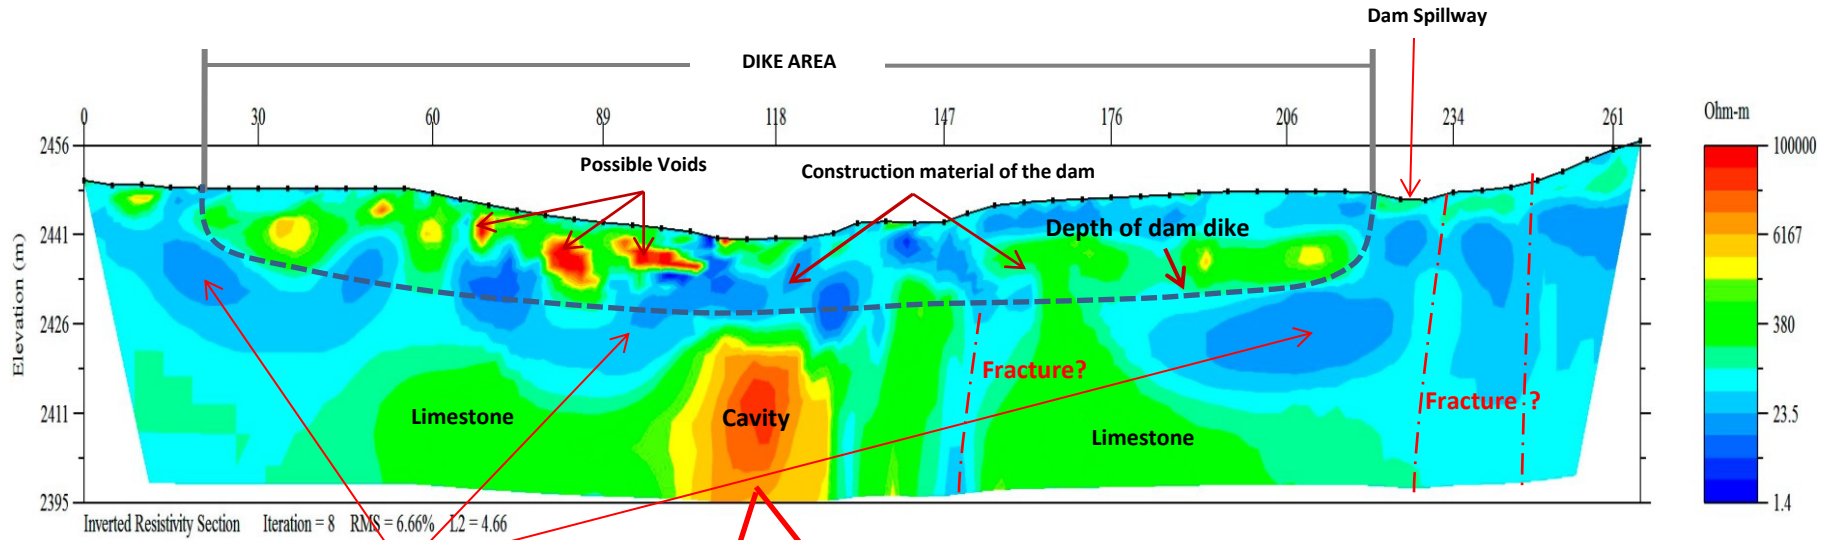
**Instrument:** SuperSting R8/IP/SP, 56 electrodes at 5 m. spacing, using Gradient array.

**Software:** Inversion of data using EarthImager 2D inversion software.

**Unit:** Meter and Ohm-m.

Saturated fine-grained sediments

A landslide in an area of a dam has happened affecting part of the existing main road corresponding to Pamplona – Cúcuta. It is important to know the possible presence of cavities in the area and saturated zones. The local geology corresponds mainly to Cretaceous sediments with the presence of clays and fine-grained sediments as well as to massive layers of limestone and marl. A 2D Resistivity Imaging study has been carried out to evaluate a problem of landslide in this area and the possible presence of cavities. SuperSting R8 RES/IP instrument with 56 passive electrodes at 5 meters spacing with Gradient array for data acquisition and EarthImager 2D software were used for data processing and inverse modeling. A large cavity below the dam has been found as indicated in the 2D Resistivity Imaging section with high resistivity values. Areas with saturated fine-grained sediments associated with low resistivity values have been correlated in the field.
